# CONNECT SERIES

Roller Brake Testers

Technical Information

Instructions for Updating the Firmware

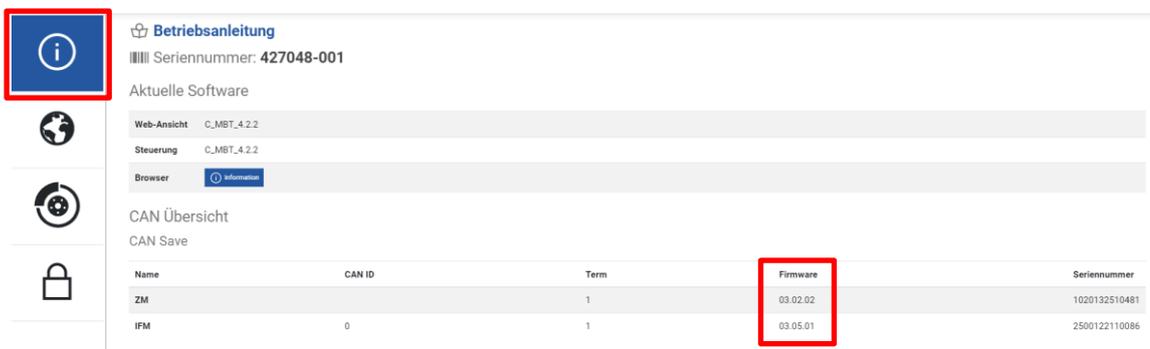
Name	CAN ID	Term	Firmware	Seriennummer
ZM		1	03.02.02	1020132510481
IFM	0	1	03.05.01	2500122110086

The currently installed firmware version can be found in the Info menu.

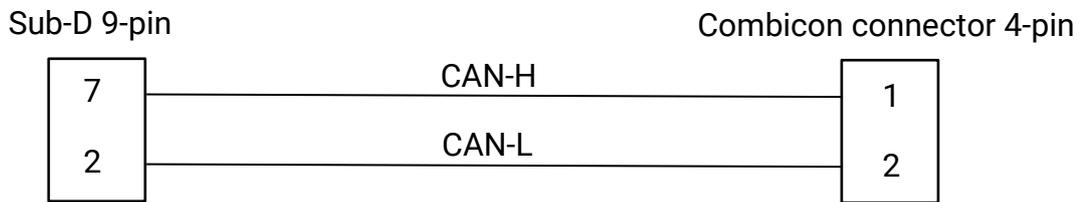
#### 3.1 Circuit Diagram ZM Update Cable

Art. no. 1406593 (= 1 set of adapter cables, contains ZM update cable and IFM update cable)

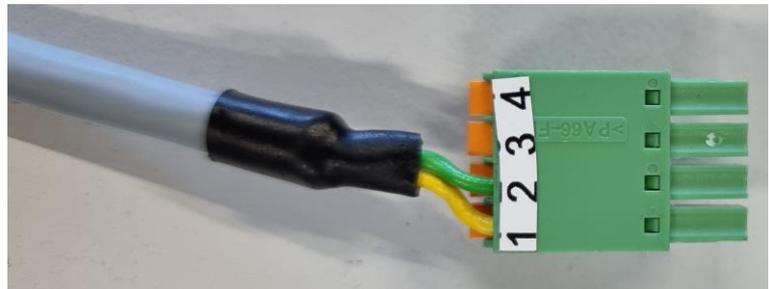
Combicon connector of ZM update cable

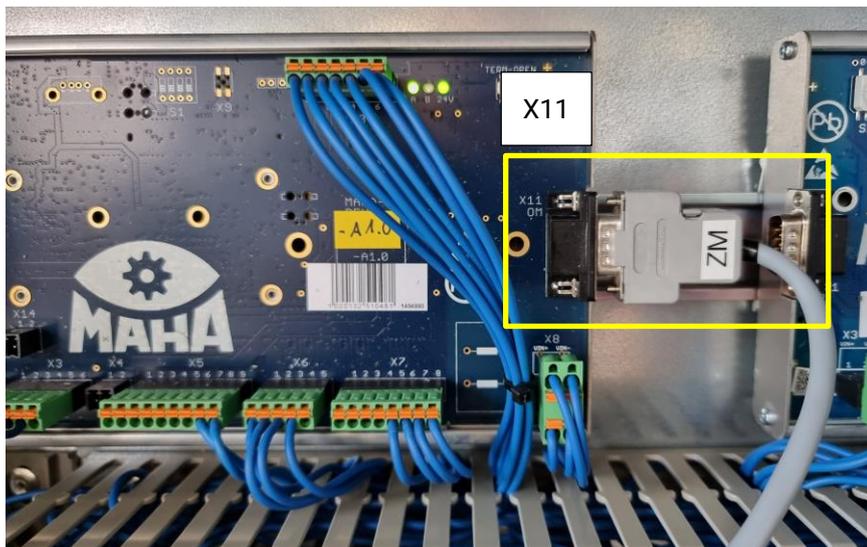
- 1 Turn off the main switch of the test stand.
- 2 Connect the ZM update cable with *one* Combicon connector:
  - 2.1 Disconnect the option module (if present) from the central module.

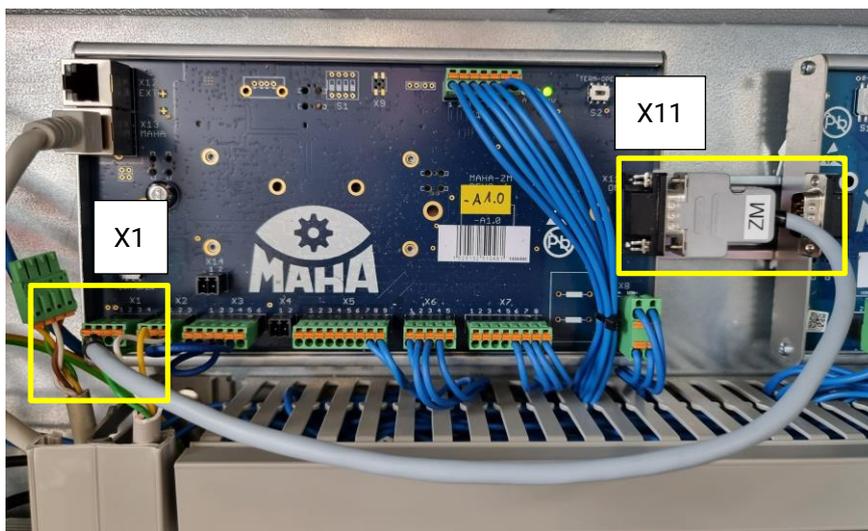
2.4 Disconnect the IFM-CAN cable from X1 of the ZM and connect the four-pin Combicon connector of the ZM update cable instead.

Overall view after connecting the ZM update cable

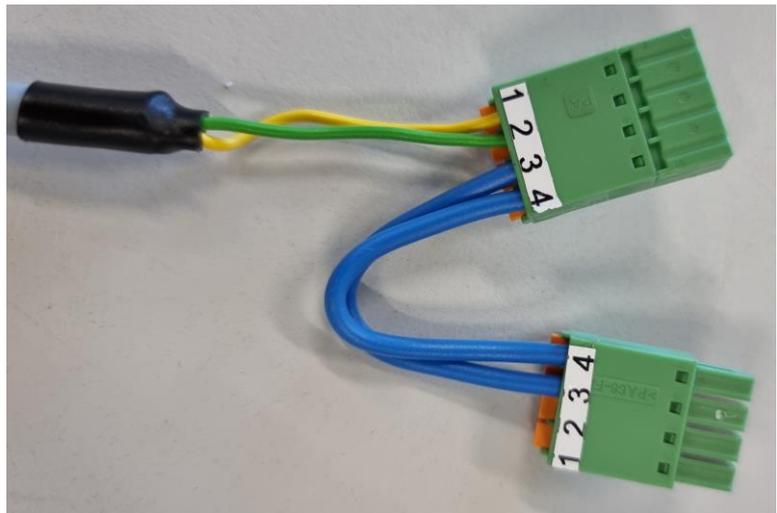
Combicon socket and  
connector of IFM update  
cable

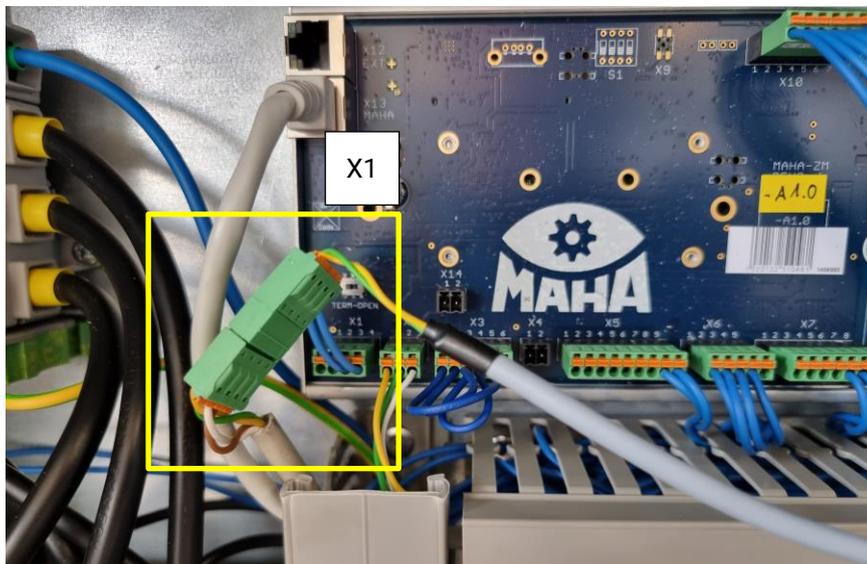
2.3 Note existing CAN termination at S2 and S3 of the ZM so that it can be restored after updating.

Then make the following settings: S2 OPEN | S3 TERM

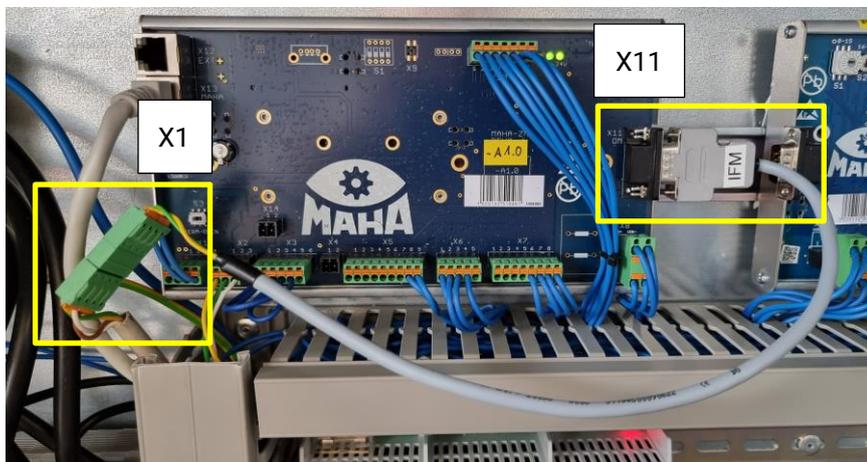
2.4 Disconnect the IFM-CAN cable from X1 of the ZM and connect the four-pin Combicon connector of the IFM update cable instead.

2.5 Plug the IFM-CAN cable into the Combicon socket of the IFM update cable.

Overall view after connecting the IFM update cable
